**E. ANTHONIS LAKE**

**FRANKLIN COUNTY, MISSOURI**

**MO 31135**

**PHASE 1 INSPECTION REPORT  
NATIONAL DAM SAFETY INSPECTION**

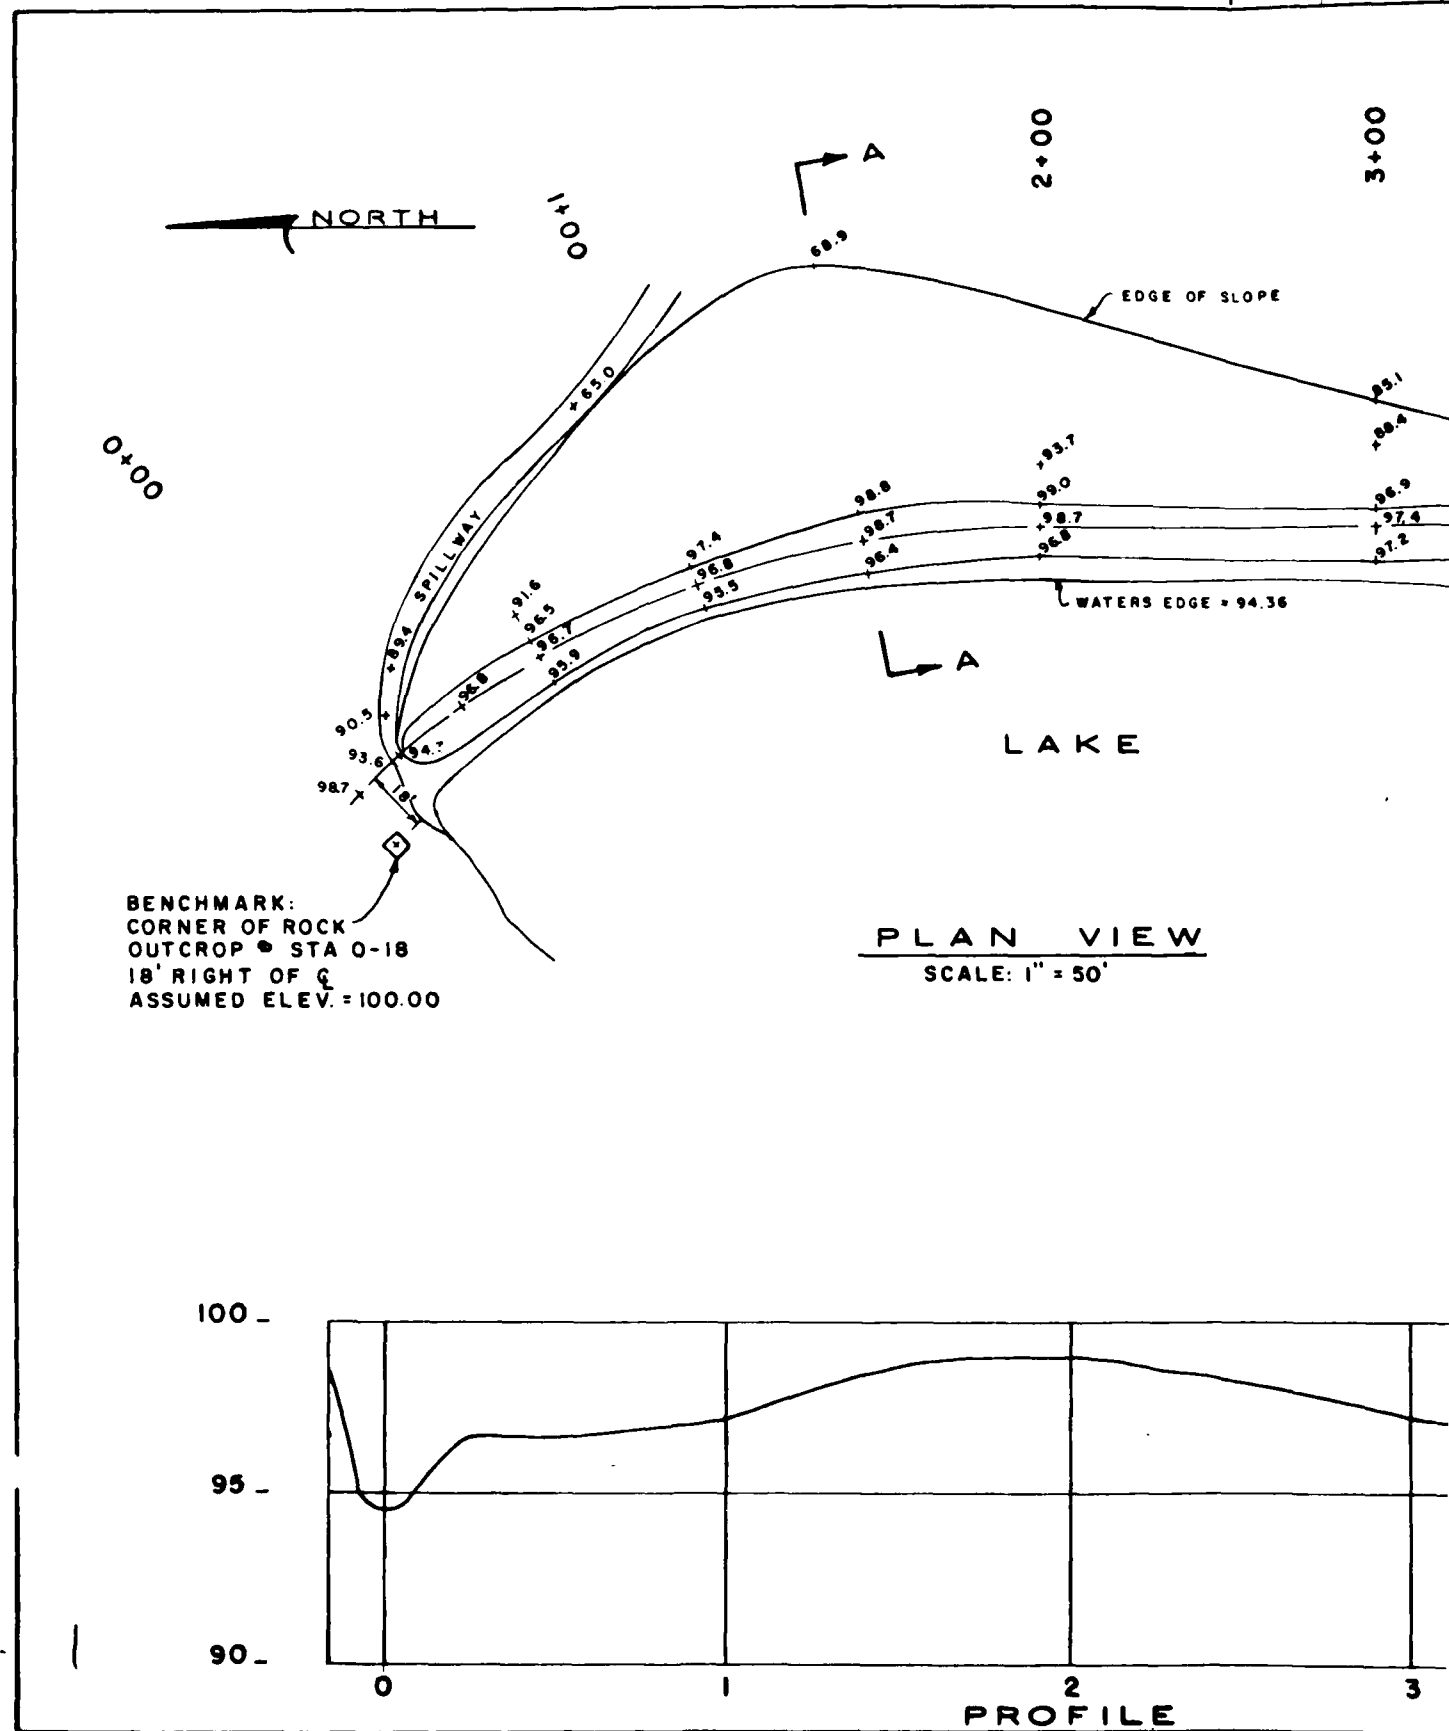
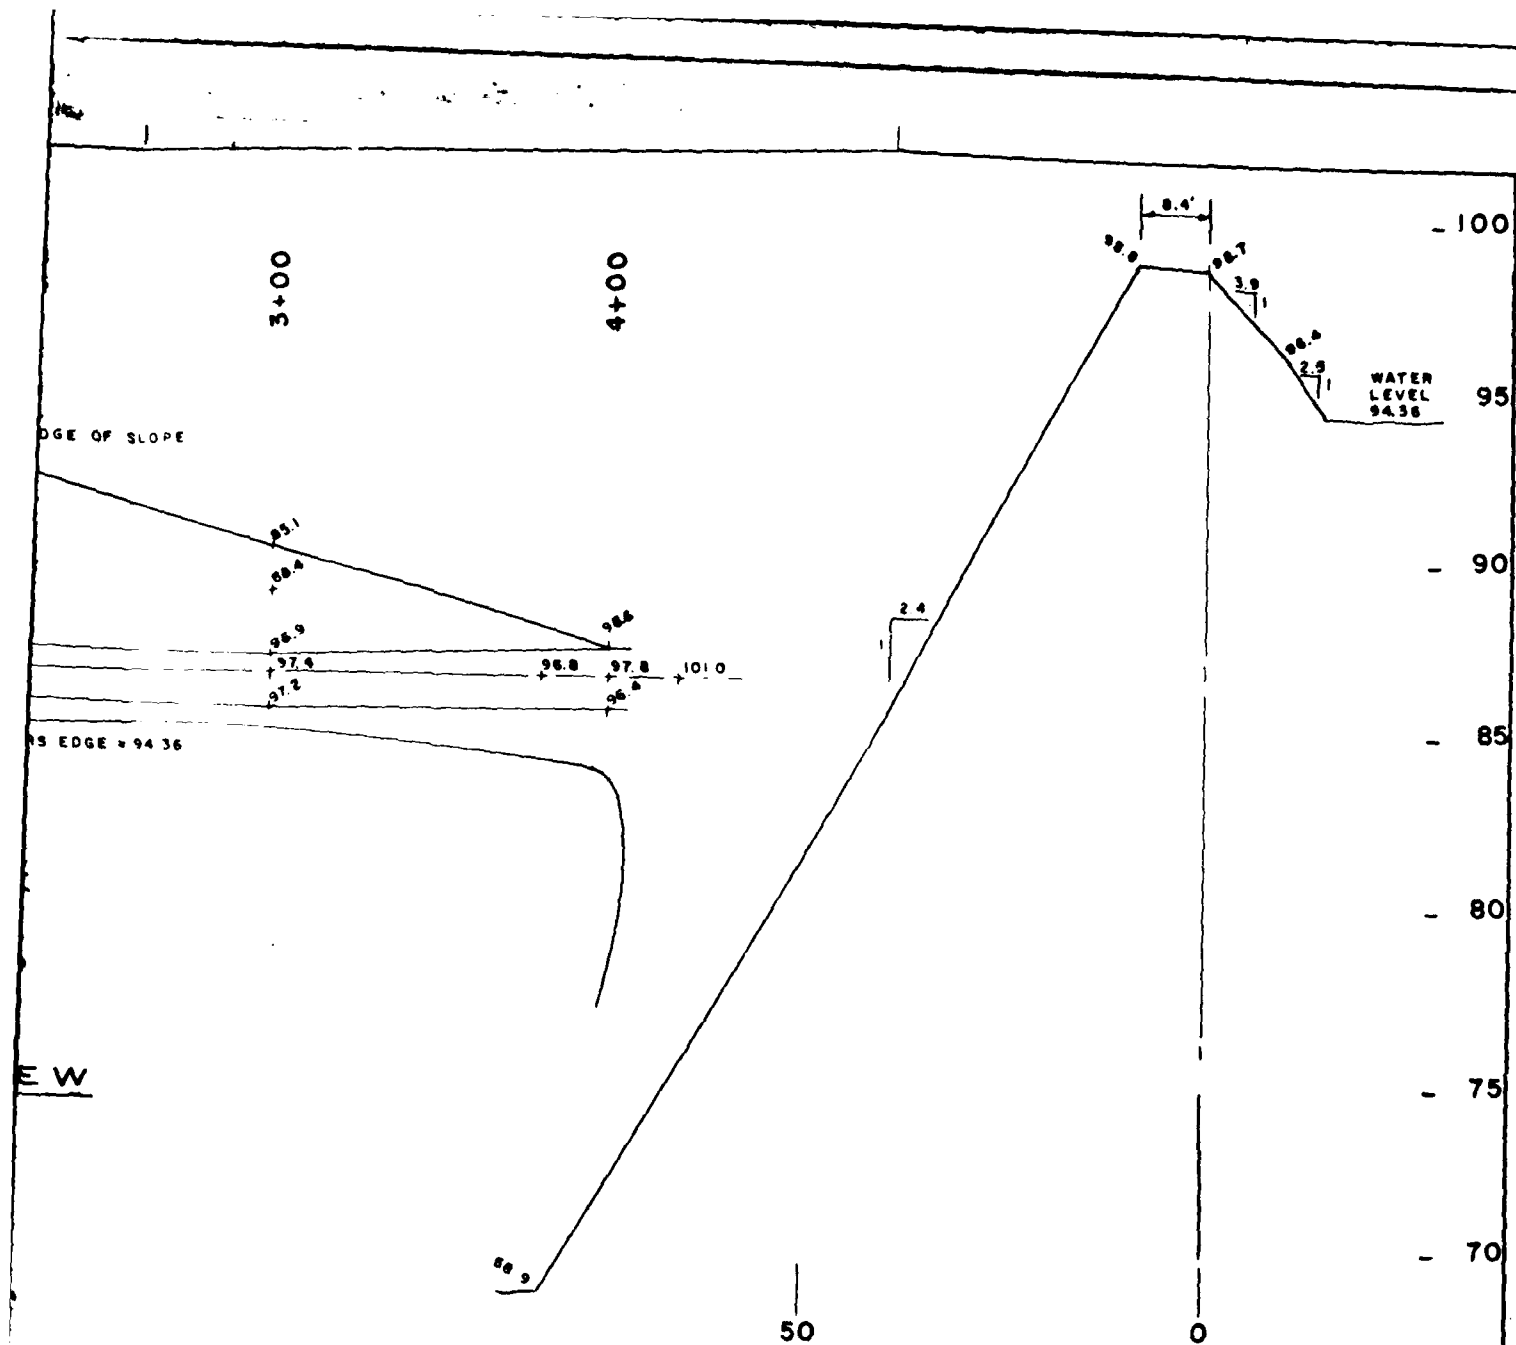
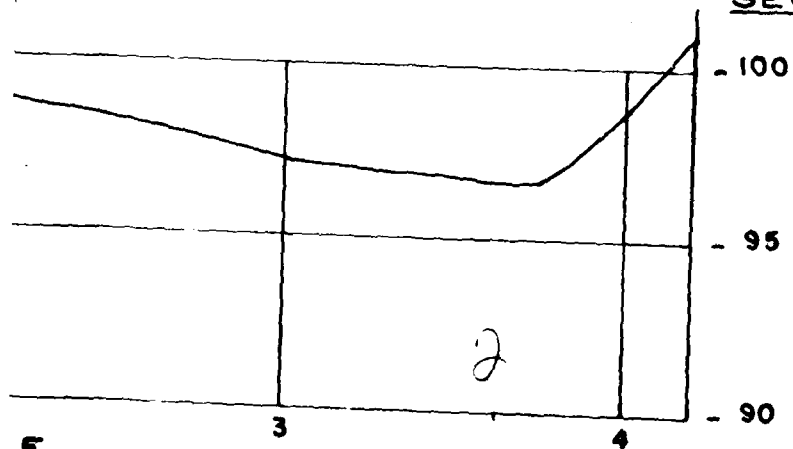
Sheet 3 Appendix A

E. Anthonis Dam is an earth fill structure approximately 39 ft high and 420 ft long at the crest. The only spillway associated with the dam is an unlined earth swale (uncontrolled crest) around the north abutment. Sheet 3 of Appendix A shows a plan profile and typical section of the embankment.

All elevations are consistent with an assumed elevation of 100.00 for the corner of the rock outcrop at Station 0-18, 18 ft right of centerline (see Sheet 3, Appendix A).

(5) Side Slopes: Upstream Irregular; Downstream 2.4H to 1.0V (See Sheet 3, Appendix A)
